Inspection Photo Log

Water/NPDES Compliance Evaluation Inspection Potomac Electric Power Company (PEPCO), Inc. Benning Generating Station 3400 Benning Road, NE Washington, DC 20019

NPDES No. DC0000094

September 16, 2016

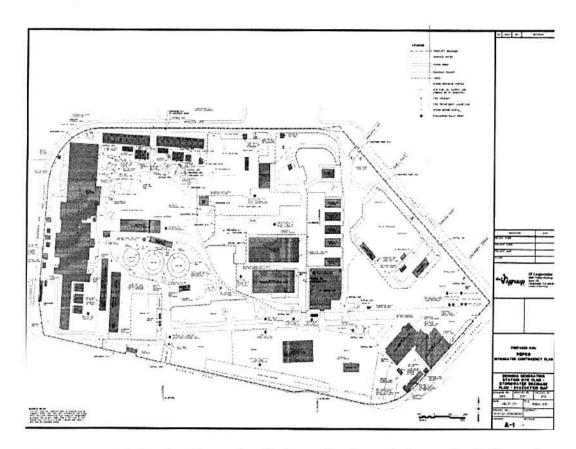
Figure 1: PEPCO Benning Generating Station - site plan and stormwater drainage plan

The PEPCO Benning Road Generating Station (the facility) is located on approximately 77 acres of land in northeast DC. The facility consists of the footprint of a former power generation station, a 230 kV switchyard, a 69 kV switchyard, fleet services, office and security services, transmission and distribution shops, transformer repair and testing shops, storage buildings, several parking areas, a hazardous waste/PCB handling storage facility, hazardous waste accumulation trailer, asbestos trailer, subsidiary and contractor facilities, and various outdoor storage areas (Figure 1).

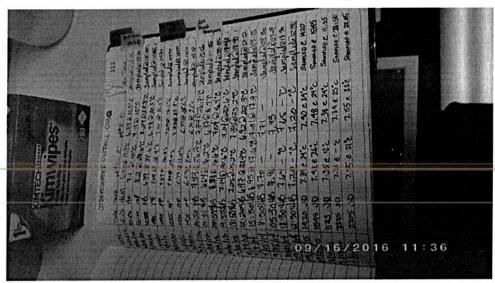
Photo 3. pH and Temperature Records

The facility's Stormwater Pollution Prevention Plan was revised in September 2015 (SWPPP) (Photo 1) and the SPCC; monthly and weekly stormwater inspection reports; OWS maintenance reports (Photo 2), pH/temperature measurement logbooks (Photo 3); pH calibration logs (Photo 4); and Total Maximum Daily Load (TMDL) reduction reports were all reviewed as part of the inspection. These reports were found acceptable.

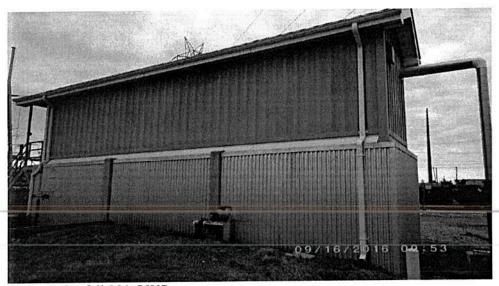
Photo 5. Outfall 201 OWS

- (i) The OWS/settling system at Outfall 201 (**Photo 5**) was designed to remove oil and grease from utility wastewater and a No. 2 fuel oil loading area. Monitoring point 201 is the discharge point from this OWS. In 2011, the facility installed a new OWS system, which is currently operational and in-service and plans to maintain it for the treatment of stormwater.

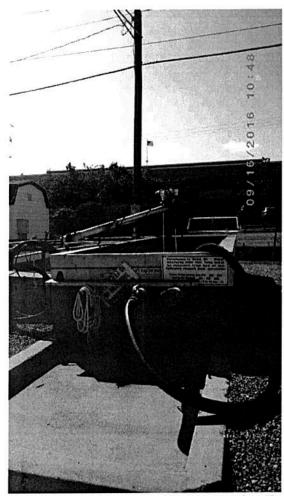
Photo 6. Outfall 003 OWS Sedimentation Tank

- (ii) OWS/settling/filtration system at Outfall 003 (**Photo 6**) is a treatment system designed to remove oil, grease, and solids from water extracted from utility manholes throughout PEPCO's service area. The treatment system operates in batch mode and consists of an OWS, storage, and settling tanks followed by a two staged filter system of cloth and charcoal media (**Photo 7**). The treated effluent is held in an underground tank from where samples are collected and sent to an off-site laboratory. Once testing confirms no contaminants are present above effluent limits, the batch is pumped through Outfall 003 to the Outfall 013 pipeline. If necessary, pH is adjusted before discharging.

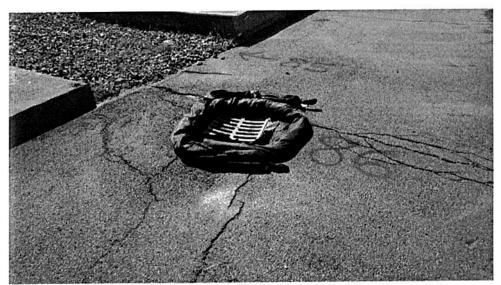
Photo 8. Inlet Protection BMPs

Stormwater runoff from the facility is conveyed through a drainage system and is discharged to the Anacostia River and the Districts Municipal Separate Stormwater System (MS4) at various outfalls. Most of the stormwater runoff from the PEPCO's service center area is conveyed through a 36-inch and 54-inch storm drainpipe to the Anacostia River via Outfall 013. Stormwater catch basins within the demolition area have been covered with filter cloth, oil absorbent booms, and rip-rap (Photos 8 and 9) to remove excess debris generated during demolition from entering the basins.

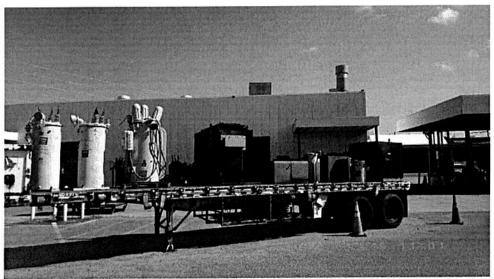
Photo 10. Transformers prepared for removal offsite, note there is no evidence of leakage or staining

Transformers were on pallets and properly contained in case of any spills. The operations appear to be properly handling and disposing of oils and protecting storm drains from any potential spills.

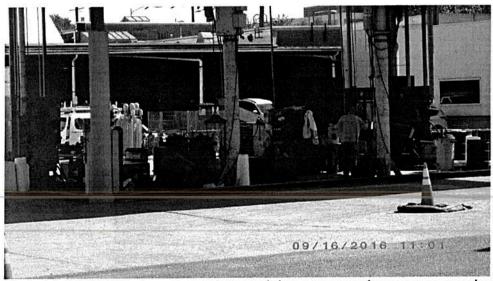
Photo 11. PCB/Oil tools and materials receiving area, note the concrete containment berm and onsite staff for handling and receiving wastes

The facility continues to receive old transformers and test oil for PCBs as part of remediation efforts. All parts and tools potentially containing or exposed to oils are collected in drums and set inside a receiving area which is surrounded by a concrete berm (Photo 10). Oil Samples are placed in a receiving box with chain of custody forms. Old transformer oil is tested, pumped to holding tanks and then later removed and disposed of by a contractor based on its concentrations. Any wash water generated while cleaning these materials is collected in holding tanks then later pumped and disposed of. The receiving and recycling/disposing transformer operations area was clear of any visible oil spills and was monitored by staff during the inspection (Photo 11).

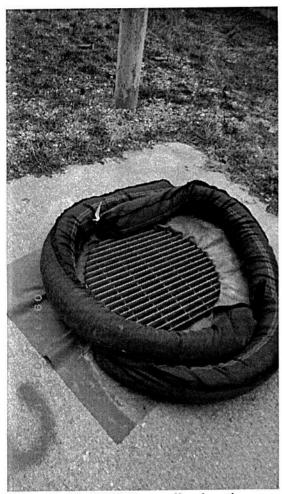
Photo 12. Outfall 013 sampling location

Effluent samples for Outfall 013 are collected quarterly at a manhole (Photo 12) roughly five hundred feet upgradient from the end of the discharge pipe for TSS, oil & grease, PCBs, and metals (Cu/Pb/Zn/Cd/Fe). Samples for Outfalls 003 and 201 (Photo 13) are collected at the end of their respective treatment system's discharge pipe before entering Outfall 013 whenever discharge occurs for TSS, oil and grease, and PCBs. Outfall 003 is sampled from the underground effluent holding tank prior to discharge and water is discharged only after results indicate the water is in compliance with permit requirements. Samples are collected and refrigerated before shipment to an offsite lab.

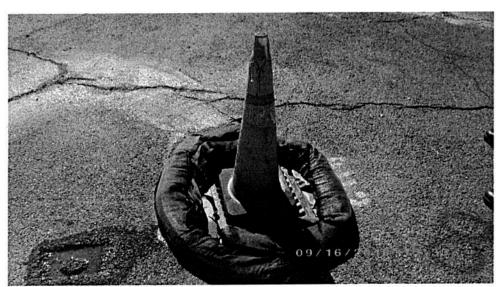
Photo 14. Outfall 101 sampling location (1 of 3)

In accordance with a study done under the permit, the facility moved the representative sampling location for Outfall 101. The investigation found Manhole K, its original monitoring location, has often been impacted by high tides from the Anacostia River. Manhole K sampling now consists of compositing grab samples from four upstream storm drains (Photos 14, 15, and 16) on the west side of the power plant that discharge to Manhole K. Samples for Outfall 101 are collected using stainless steel bailers by an independent contractor during storm events and sent to a lab.

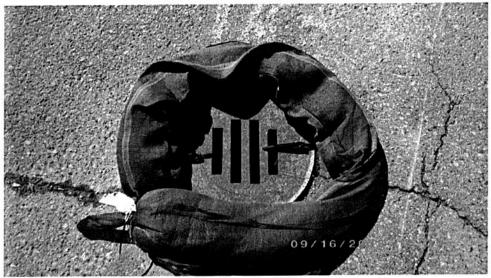
Photo 16. Outfall 101 sampling location (3 of 3)

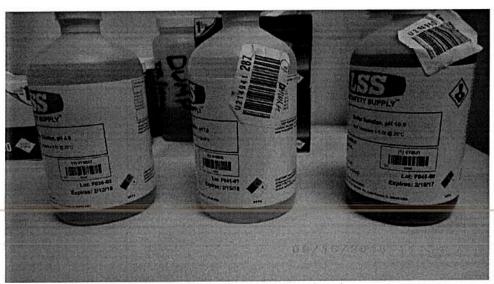
Photo 17. pH calibration solutions showing expiration dates

Samples are field analyzed for pH and temperature. pH and temperature samples are collected, analyzed, and documented in log books. Calibration log books indicated a 3-point procedure is used to calibrate pH meters for each of the monthly samples, buffer solutions (4, 7, and 10) used in their calibrations were all current (unexpired) at the time of this inspection (**Photo 17**).

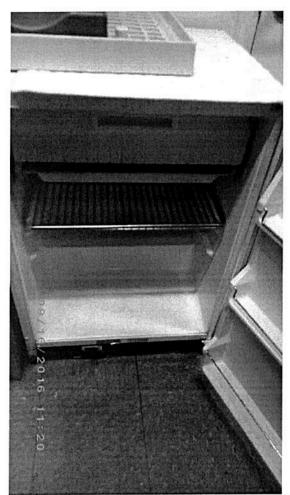
Photo 18. Water sample holding fridge, note the lack of temperature gauge

Building Lab in a refrigerator until pickup. During the 2016 inspection there was no temperature gauge in the refrigerator (**Photo 18**), however, PEPCO staff stated it had only been temporarily moved and provided a photo later that day of the thermometer returned to the refrigerator (**Photo 19**).

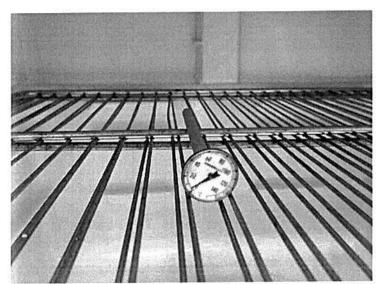
Photo 19. Photograph of temperature gauge in sample holding fridge provided by PEPCO following the inspection

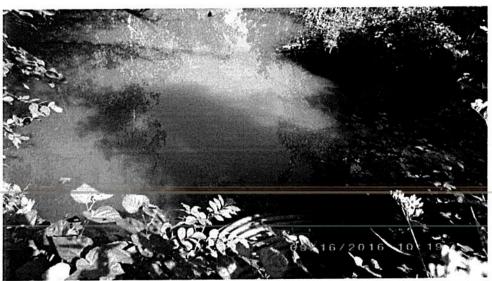
Photo 20. Outfall 013 discharge location; the water is cloudy but there was no active discharge, there are several discharge pipes in this location

The outfall discharges into a wetland, a few hundred feet from the Anacostia River. Outfall 013 was not observed discharging water during the CEI. The receiving water at the discharge point of 013 was brownish in color and turbid or cloudy in appearance (**Photo 20**). It was not apparent where the turbidity originated from but it did not seem to be directly related to the outfall. There are other outfall pipes adjacent to Outfall 013 which discharge stormwater from nearby facilities.
